Quest 506-230v: #4036600

Quest 506-277v: #4036610

OVERVIEW:

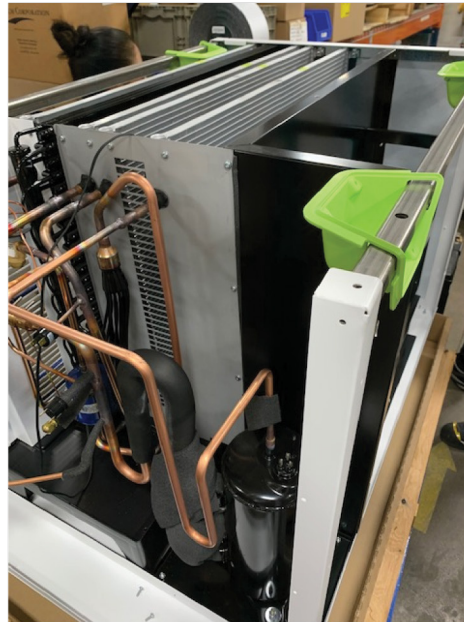
Step one is going to be removing all of the side panels. Once removed, you should have something that looks like this. Then you will go about removing the nuts on the pem studs.

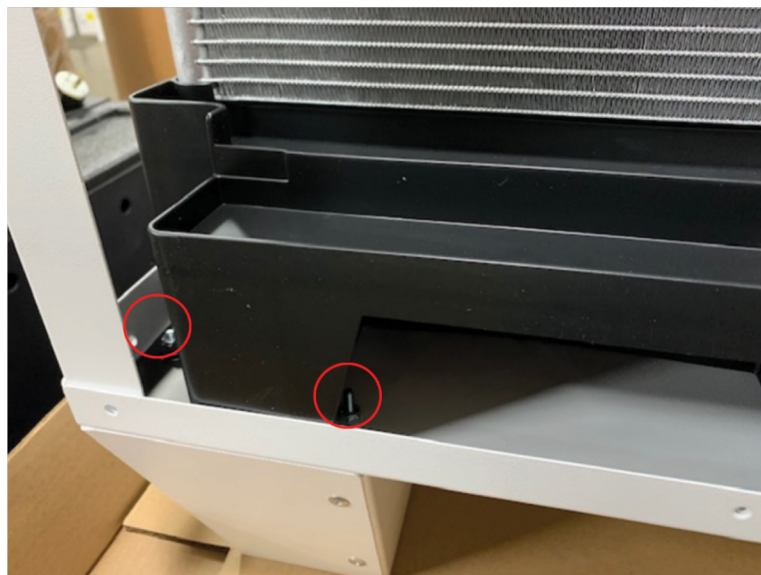
Locations 1&2

Removing the legs and replacing each hole with an equivalent bolt, nut and washers. The locations will now look like these pictures:

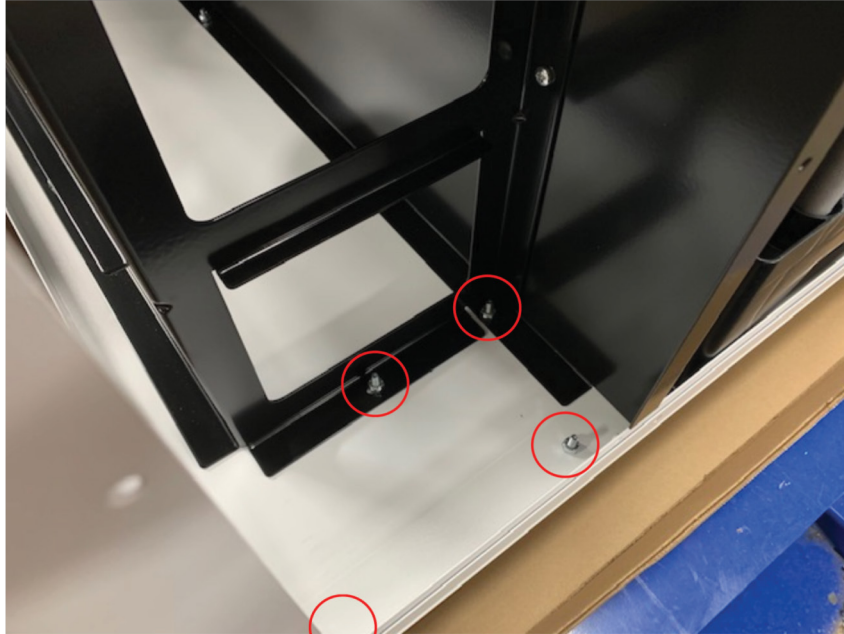
Locations 3, 4 5, 6. The one in the corner is just out of the picture.
